New Angle on Hot Box Detector

Background: In the April 1 issue *Railway Age* reported on a hot box detector recently installed on the Reading. That story ended the silence about nearly four years of thinking, planning and development of this type of detector on the Chesapeake & Ohio. Now it can be told how the C&O management timed an order for equipment so as to insure its proper development, showing the manufacturer a willingness to share in its expense.

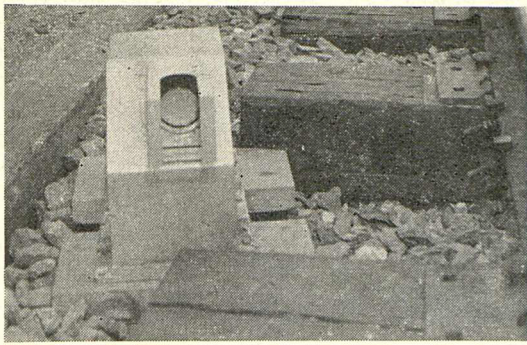
← **HOOD** eliminates "pips" caused by sunshine.

Through Norge, the tracks run almost directly east and west. In the early forenoon on some sunny days, indication "pips" were made on the chart apparently by heat from the sun or sun reflections.

To eliminate this condition, small sheet metal hoods of a special design were applied to the detectors. They have eliminated this type of faulty operation.

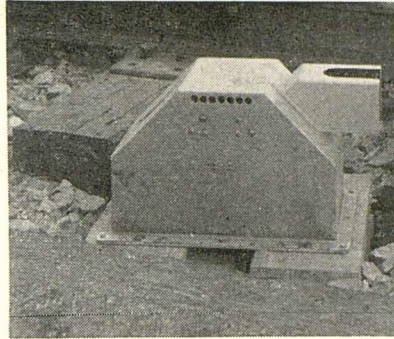
10° ANGLE ↑ toward rail minimizes effect of higher bearing temperatures.

The boxes on freight cars equipped with roller bearings consistently run at higher temperatures than are normal for solid bearings, the differences being readily identified on the graph sheet. To eliminate recordings that may indicate hot boxes for what are actually normal roller bearings, the C&O is now making further experiments.

For example, the detector, instead of being parallel to the rail, is turned 10 degrees toward the rail so that the "scan" line from the lens of the detector is nearer to the end of the box as the bearing recedes. As a result, the detectors now give a better "pip" indication of the temperature of all

bearings. And indications by roller bearings are closer to the normal indications made by solid bearings.
