Erie Installs Its First Hotbox Detector

First hotbox detector installed by the Erie is at River Junction, N. Y., 65 miles east of Buffalo. Journals on eastbound freight trains are checked. The detector, with its automatic alarm system, is interconnected with the signal system. A signal $2\frac{1}{2}$ miles beyond the detector is set to Approach, and another signal 5 miles beyond the detector is set to Stop. Hotbox indications are sent to the Buffalo dispatcher's office.

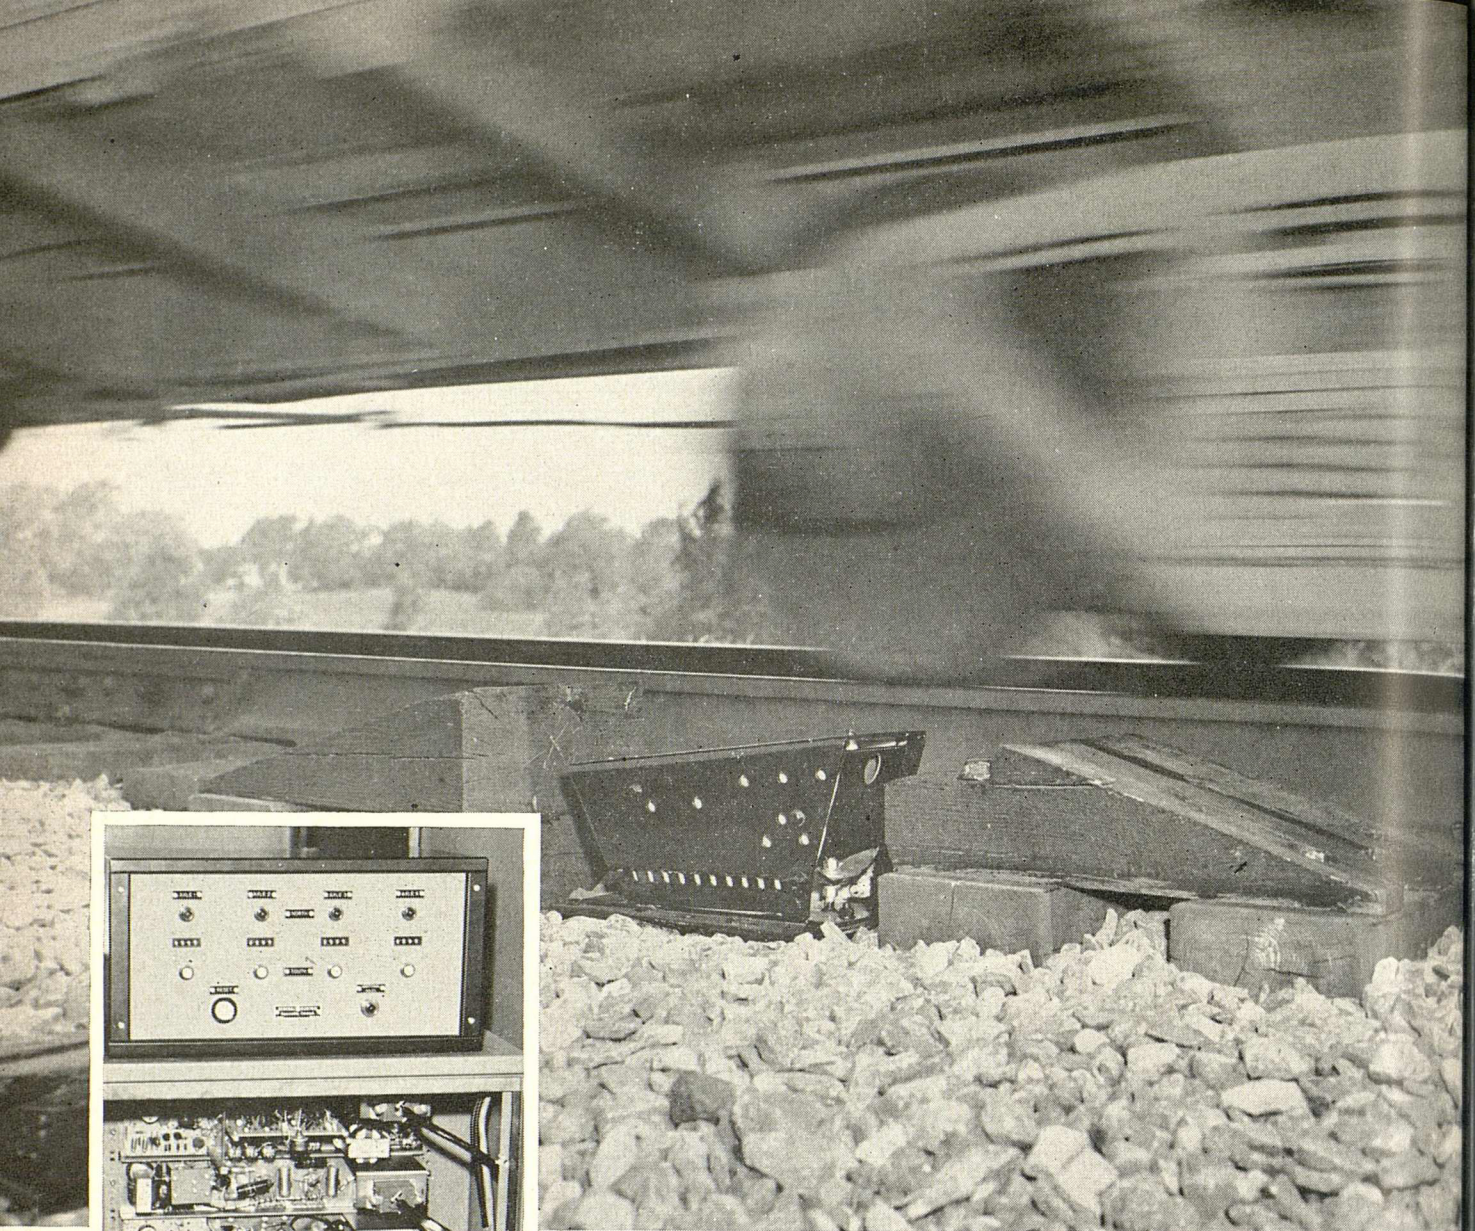
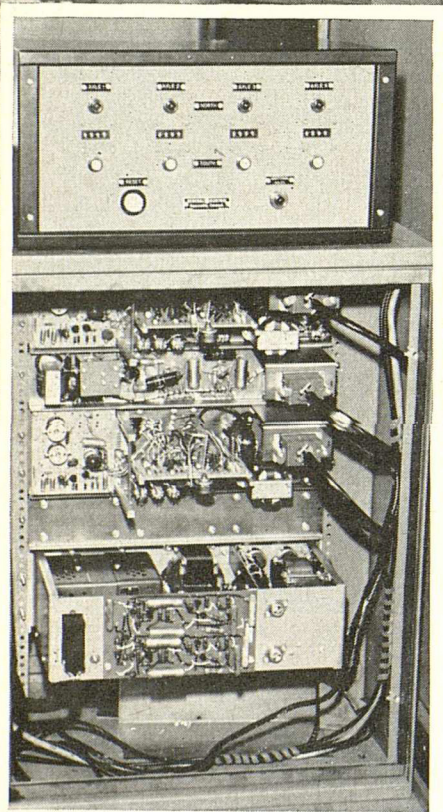
Hotbox detector views journal for one ten-thousandth of a second. Indications are sent 65 miles to dispatcher's office where hotbox indication alarm equipment (inset) registers up to four hot journals on a train.

The hotbox location counters can indicate up to four hot journals on a train. The railroad has not experienced over four hot journals on one train since the detector was placed in service on August 2. Also, at the dispatcher's office is a pen graph recorder that records on a paper tape the detector readings of the journals. The dispatcher scans this tape, looking for potential hotboxes.

The viewing heads are mounted on separate cast iron foundations between the ties, so as to reduce vibration from passing trains. Large wood wedges are bolted on the two ties in front of and behind the detector heads. These wedges are placed to prevent dragging equipment from damaging the detector heads.

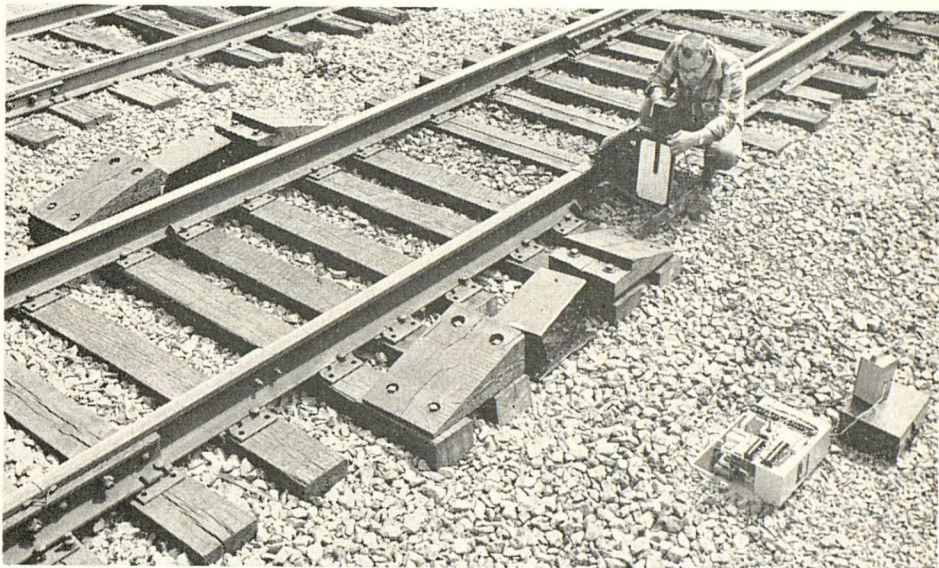
Maintainer aligns detector head using an electric light for a simulated hotbox. Light is mounted on template attached to rail to provide proper spatial relation of detector head and car journal.

ing the detector viewing heads, the maintainer has a wood template and a light source to simulate a hotbox. The wood template fits over the top of the running rail and is so shaped to provide the proper spatial relation between the light source and the hotbox detector viewing head.

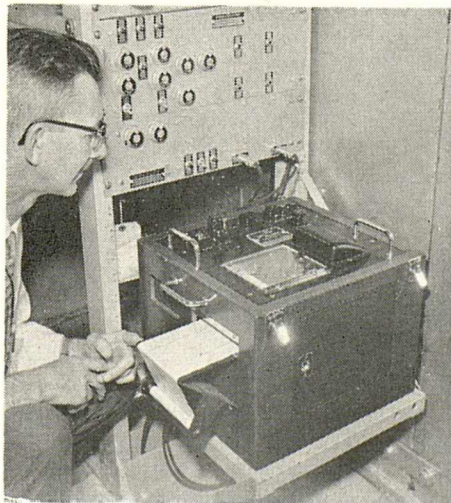
Pengraph recorder and test panel at the hotbox detector location aid maintainer in detector preventive maintenance.

At the River Junction hotbox detector location a relay housing contains, in addition to the amplifier and carrier equipment, a panel with test jacks, pushbuttons, toggle switches and adjustable potentiometers necessary for the adjustment of the hotbox detector and its associated equipment, as well as the carrier equipment which transmits the hotbox detector and automatic alarm indications to the dispatcher's office, 65 miles distant. A pen graph recorder is also located at River Junction, which is helpful to the maintainer when he is adjusting and aligning the detector. For align-

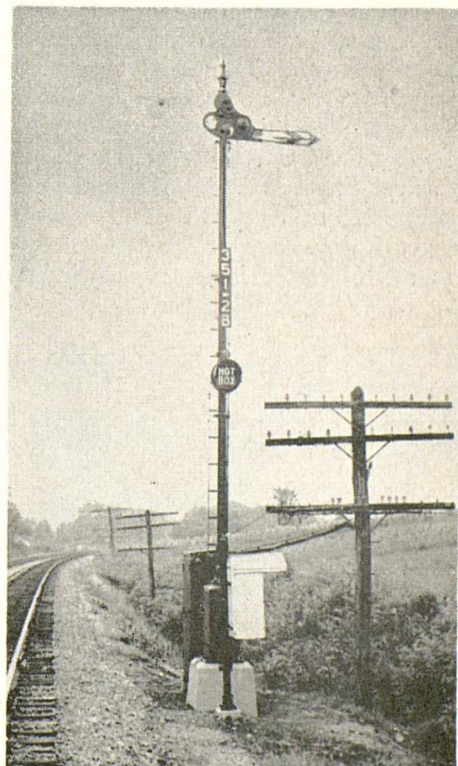
Automatic block signal is controlled to Stop position when detector indicates a hotbox. Control is automatic.

will sound, and a counter will begin to count axles remaining in the train. At the same time a signal two and one-half miles ahead of the train is controlled to display the Approach aspect and another signal five miles ahead of the train displays the Stop aspect. At both signals an indicator is lighted which displays white letters "Hot Box" on a black background. The words "Hot box" are placed vertically one above the other.
